# Additional Strengthening of “Screper” Jewelry Tool Using Friction

**Abstract.** This study is aimed at strengthening the working surfaces of the jewelry tool - scraper. This tool is used for fine cutting work. The object of research is a method of additional thermofrictional hardening of samples of jewelry tool - scrapers made of carbon steel tool grade U8A. In the course of work the complex of metallographic, mechanical and analytical researches of samples in an initial condition after hardening and low-temperature release which includes is carried out which includes:

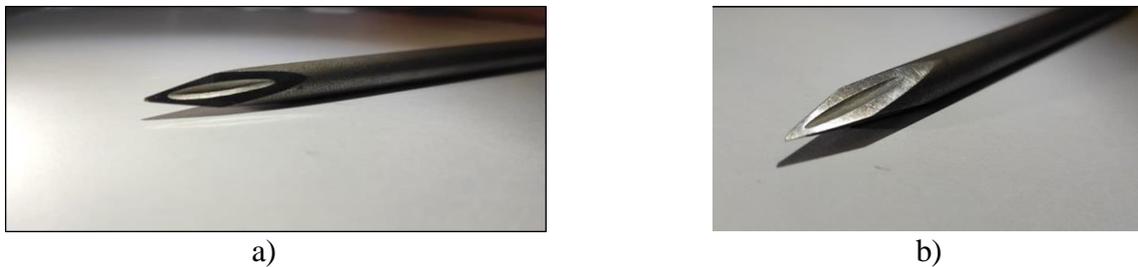
In this research work, two samples of jewelry tools were studied – a scraper 120 mm long and 7 mm in diameter with a triangular working part, made of U8A steel (Fig. 1, a).

**Fig. 1.** Scraper for jewelry work: a – in normal form; b – with traces of wear

When conducting macroscopic analysis of scraper samples of U8A steel in the state after hardening and low-temperature tempering, which were not strengthened by friction and operated under standard conditions, it is seen that the cutting edge is damaged compared to the initial state (Fig. 1, b).

The nature of wear is the appearance of jags and blunting of the cutting edge. Local chips are also possible (mainly when the cutting edge of the scraper is in contact with hard materials or other tools, solid particles of various origins, as well as when the scraper is working on twisting or bending). Blunting occurs gradually in the process of cutting metals with this tool by wiping.

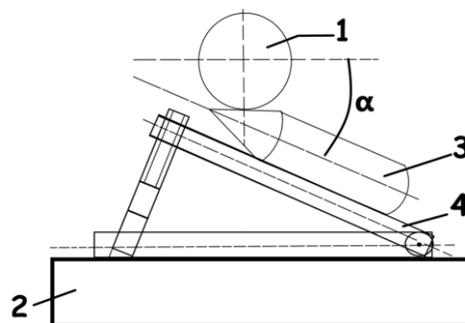
Thermofrictional strengthening (TFS) was performed on a surface grinding machine. The samples were fixed on the magnetic plate of the flat grinding machine using a special device to ensure the possibility of processing the strengthening disk in the horizontal plane. The scheme of processing is presented in fig. 2.

**Fig. 2.** Scheme of thermofrictional strengthening: 1 – cutting disk; 2 – magnetic plate of the machine; 3 – sample of scraper; 4 – device for adjusting the angle of the sample

The reinforcing disk is made of St3 steel. It was used to a depth of 0.4 mm. This choice of machining depth is made taking into account the small cross section of the tool to be strengthened.

Moving the table at a speed of 30 mm/s allowed TFS on the entire surface of the cutting edge. When making contact between the cutting disc and the sample was implemented TFS, which was carried out in conditions without lubrication. Thus, the selected TFS mode is limited by the level of rigidity. TFS was carried out on one of the three surfaces.

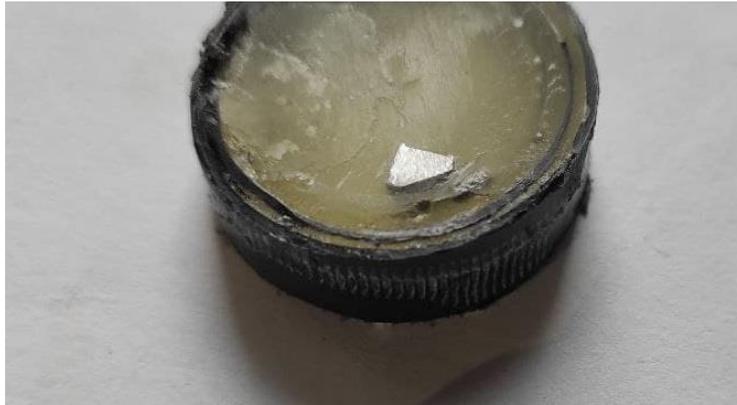
x2

In order to provide metallographic analysis of steels, after TFS, micro-sections of samples with a triangular cross-section were made of U8A steels. They were placed in cylindrical polymer containers and filled with epoxy glue. In the manufacture of microsections, samples were processed on 4 numbers of sandpaper (sanding), followed by polishing by standard technology. The finished sections (Fig. 3) were etched in 4 % alcoholic solution of nitric acid ( $\text{HNO}_3$ ) according to standard methods.

**Fig. 3.** Microgrind prepared for metallographic analysis

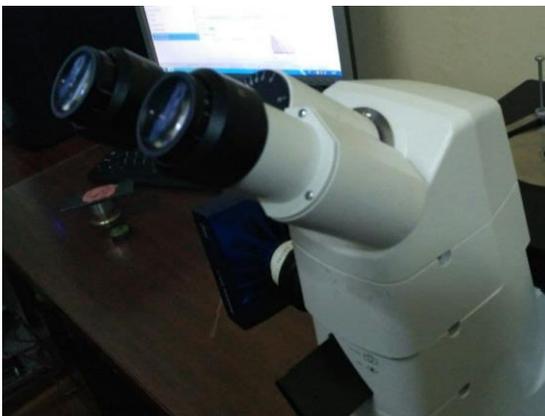
The study of the microstructure was performed in the cross sections of the samples, which were further strengthened by friction on one of the three surfaces. The study of the microstructure was performed using a metallographic microscope ZEISS AXIO Vert. A1. Photographing of microstructures was performed using a digital camera, which is adapted to the microscope, as shown in Fig. 4.

**Fig. 4.** Metallographic microscope ZEISS AXIO Vert.A1

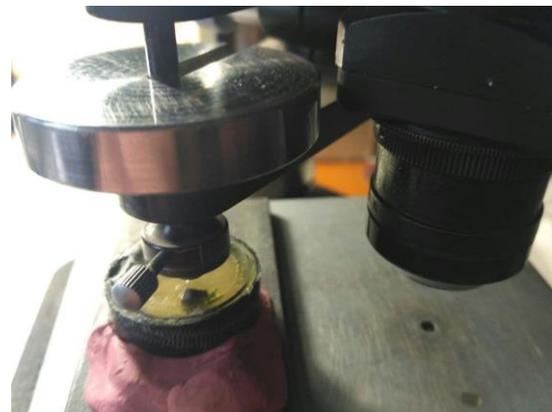
To identify the combined effect of TFS factors on the structure of the samples and their properties, microhardness was measured using a microhardness tester PMT-3 according to standard methods (Fig. 5) at static loading by diamond indenter indentation  $P = 100$  g. Based on visible changes in the structure and data on the microhardness of the cross section of the samples, it becomes possible to reliably determine the depth of the layer with the changed structure obtained under the influence of TFS and draw conclusions.

**Fig. 5.** Measurement of microhardness on samples

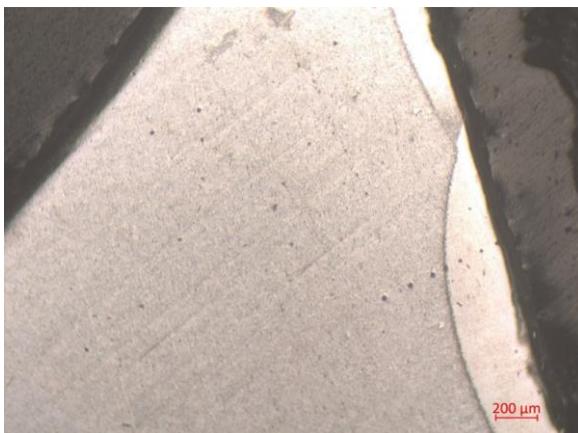
x 50

**Fig. 6.** Microstructure of the cross section of the scraper sample in the triangular nasal part, reinforced by friction on one side

Macroanalysis of the cutting edge of the scrapers shows their low operational stability. As a result, there is a need for processing that could increase the hardness of the work surface and, consequently, the operational stability of the tool. Therefore, the prepared samples of U8A steel were thermofrictionally strengthened on one of the three surfaces. The treatment was carried out on only one surface to compare the properties obtained in one pass of TFS with the part of the tool that is strengthened only thermally. The microstructure of the experimental sample for these studies is presented in Fig. 6.

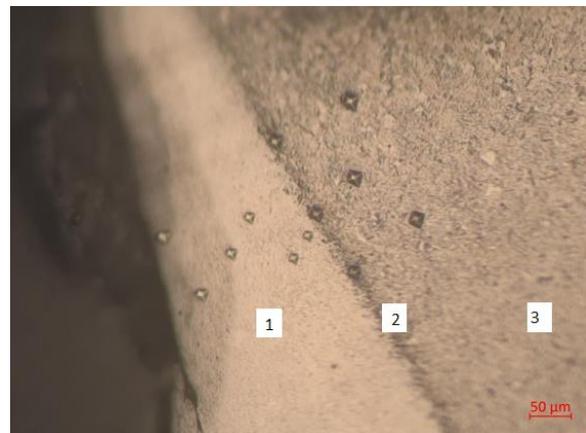
× 200

**Fig. 7.** Microstructure after measuring the microhardness in the cross section of the sample of scraper closer to the cutting edge: 1 – strengthening zone (white layer); 2 – weakening zone (transition zone); 3 – the main part of the sample (without structural changes)

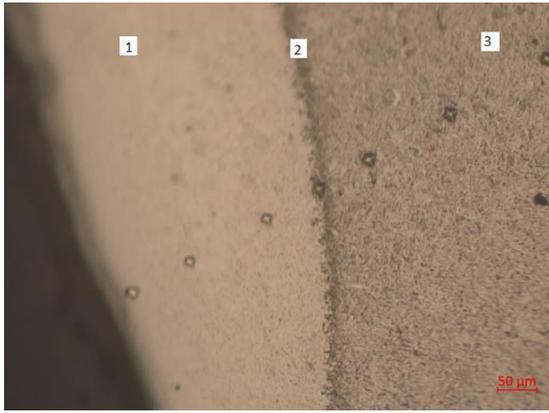
× 200

**Fig. 8.** Microstructure after measuring the microhardness of the section closer to the middle of the face

From those shown in Fig. 8, 9 and 10 photos of microstructures of the sample type "scraper" of U8A steel after additional thermofrictional strengthened, it is seen that in the cross section of the samples there are two additional zones. Thus, the cross sections of the samples include:

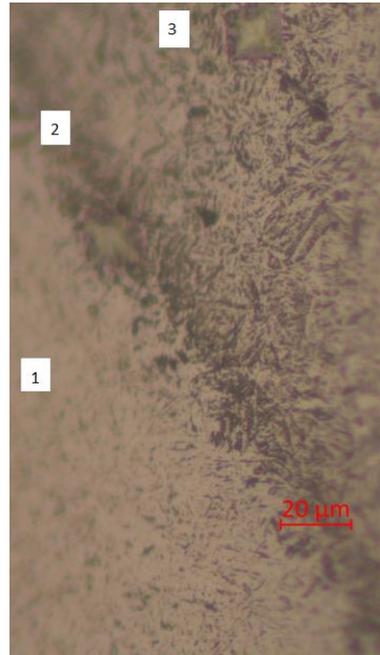
x500

**Fig. 9.** Microstructure of the transition zone in the cross section of the sample: 1 – strengthening zone (white layer); 2 – weakening zone (transition zone); 3 – the main part of the sample (without structural changes)

The appearance of zone 2 (weakening) is caused by the fact that in TFS heat flow is directed from the surface into the sample and at a certain depth from the surface residual heat can cause the beginning of the decay of martensitic structure. That is, in this area, which has a small thickness, partial release processes take place. Accordingly, the microstructure in this zone has a troostite-like nature (see Fig. 9), which is explained by the partial passage of the average holiday in the local area.

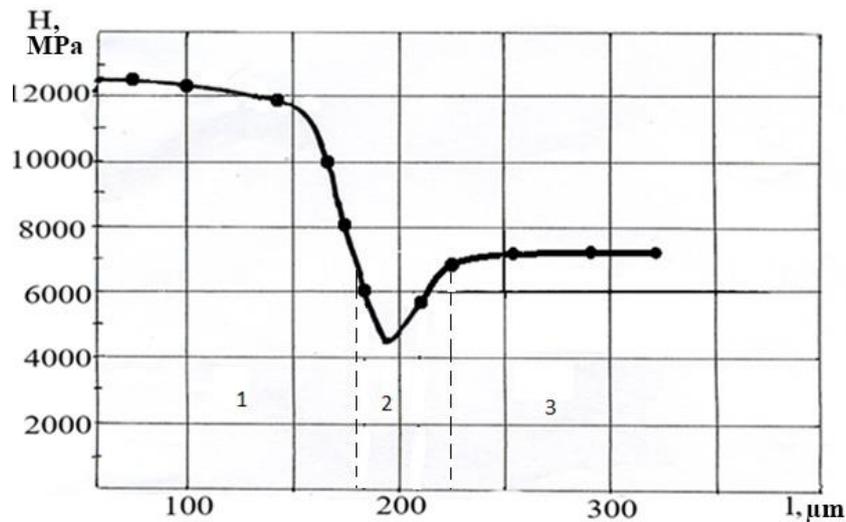
According to the obtained results, the maximum microhardness of the “white layer” obtained by TFS is equal to  $H_{100} = 12200$  MPa at the depth of hardening  $l = 170$  μm. The structure of this layer corresponds to the deformed martensite, which received deformation with hardening at the time of short-term heating at TFS to high temperatures (Fig. 10).

**Fig. 10.** Graph of microhardness distribution along the depth of the sample of U8A steel scraper after hardening, low-temperature tempering and thermo-friction strengthened: 1 – strengthened zone (white layer); 2 – weakening zone (transition zone); 3 – the main part of the sample (without structural changes)

Below the cross section of the sample – the heat is dissipated, but there is no effect of TFS. Accordingly, the main part of the sample has a microstructure - martensite of tempering, which is caused by pre-heat treatment.
