Studying Fire Hazard of Premises of a Mobile Communications Base Station

Abstract. The need to study the fire hazard of typical premises of a mobile communications base station was substantiated, in particular, regarding the feasibility of equipping it with an automatic (self-contained) fire-fighting system. Criteria for assessing the fire hazard of a mobile communications base station were developed. It was experimentally established that the greatest fire hazard in the premises of a mobile communications base station was related to the following devices: Alarm Box switching panel, input and distribution board, internal air conditioner unit and 12 V 100 A#2 batteries. Moreover, the latter two ones contribute to the spread of fire inside the premises. During the ignition of the 12 V 100 A#2 batteries, it was established that the surface of the outer wall further heated to a temperature of 80 °C, which did not exceed the critical one. Thus, the fire did not spread beyond the premises. It was established that equipping the premises of a mobile communications base station with a fire-fighting system in order to prevent the fire spreading beyond its boundaries was unreasonable.

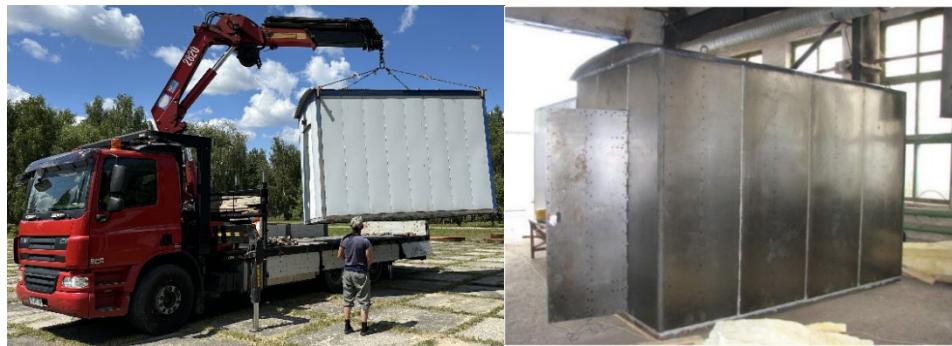
The study is conducted using a typical mobile communications base station container having a tambour and main premises to house telecommunications equipment. The main premises have internal dimensions of 2,500 mm × 2,200 mm × 2,450 mm, and the tambour is dimensioned 1,070 mm × 2,200 mm × 2,450 mm. The external and internal metal doors of the container are fire resistant. The thermal insulation is fabricated of non-combustible materials. The container floor is made of wooden boards on wooden logs (all treated with flame retardants) and covered with linoleum. The general view of the container executed of panels of black steel sheets is shown in Fig. 1.

Fig. 1. General view of a typical mobile communications base station container.

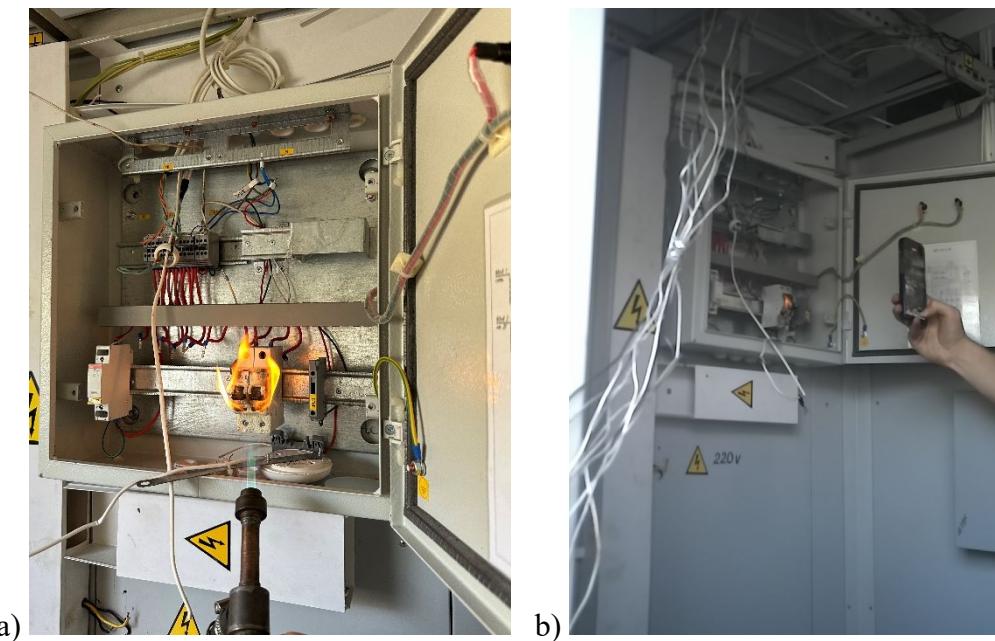
Experiment No 7: Application of the test flame to the input and distribution board of the mobile communications base station as shown in Fig. 7 a).

After the burner was removed (Fig. 7 b)), self-supported burning and formation of visible volatile combustion products (smoke) were observed for 1 min 25 s. It is worth noting the fact that the flame combustion was not supported by the circuit breaker housing, but it was supported directly by the mode switch (on/off), which was obviously fabricated of some combustible material. In this regard, the fire hazard of the input and distribution board increases significantly, and being fully equipped with circuit breakers it can become a source of fire spreading inside the premises of the mobile communications base station.

Fig. 7. Experiment No. 7 on applying the test flame to the input board of a mobile communications base station: a) place of application of the test flame to the input board; b) reaction to fire of the input board.

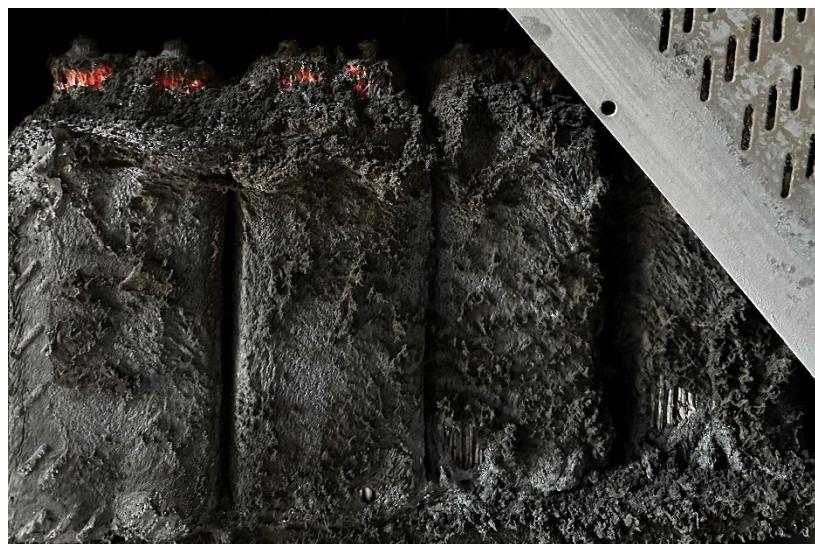
After opening the PSS SHZh power supply cabinet, the 12V 100 A#2 batteries looked as shown in Fig. 14.

Fig. 14. Condition of the 12V 100 A#2 batteries of the PSS SHZh power supply cabinet upon completion of experiment No. 9.
